ELECTRICAL SAFETY FOLLOW UP INSPECTION REPORT (11TH)

Factory Name	Chittagong Fashion Specialized Textile Ltd.					Note:
Address	Plot# 26, Sector # 01, road # 04, C.E.P.Z.					
FACTORY ID	11715	ELECTRICAL SAFETY INSPECTION DATES				Other Factory:
Initial Inspection Date	23-Jun-2014	Date of 5 th Follow Up	12-Feb-2017	Date of 11 th Follow Up	28-Oct-2019	
Report Received Date	06-Aug-2014	Date of 6 th Follow Up	04-Jul-2017	Date of 12 th Follow Up		
Date of 1 st Follow Up	08-Oct-2015	Date of 7 th Follow Up	17-Oct-2017	Date of 13 th Follow Up		
Date of 2 nd Follow Up	16-Mar-2016	Date of 8 th Follow Up	12-Mar-2018	Date of 14 th Follow Up		
Date of 3 rd Follow Up	17-Aug-2016	Date of 9 th Follow Up	09-Sep-2018	Date of 15 th Follow Up		
Date of 4 th Follow Up	07-Nov-2016	Date of 10 th Follow Up	19-Jun-2019	Date of 16 th Follow Up		
Inspected by		Subrata Chakma

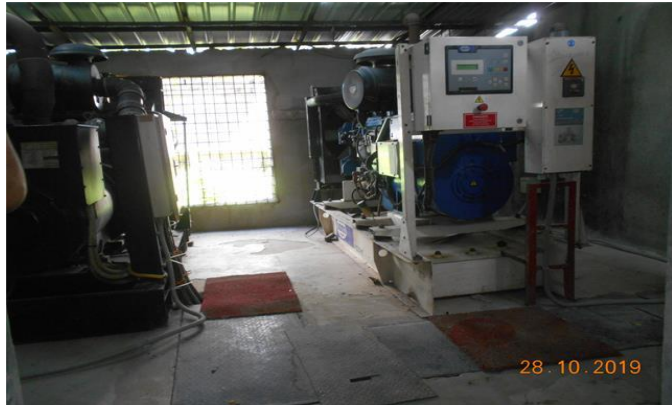
6	Generator Room: Inadequate working space around the generators (typical). Generator output cables not protected and supported.	Enlarge the existing generator room to provide sufficient working clearance around or keep sufficient clearance around the generator (1 meter preferably). Install vertical and horizontal cable tray from the generator terminal box to changeover switch to protect and support the generator output cables laid on the floor.	Within 3 Month	On 16/03/16: Generator output cables are supported now but space around generator is still congested. So, this issue is not solved yet. New committed timeline has given till 20/04/2016. Timeline Extended from 20/04/2016 to 15/05/16. On 17/08/16: Still incorreced & behind timeline. On 07/11/16: Not corrected. On 12/02/2017: Not corrected. On 04/07/2017: Not corrected. On 17/10/2017: Not corrected On 12/03/2018: No work progress has been observed. Not corrected yet. On 09/09/2018 : Not corrected yet. On 19-Jun-2019: Not Corrected. On 28-Oct-2019: Corrected.	15-May-2016	Completed	Corrected
