FIRE SAFETY INSPECTION REPORT

SPECIALISED TEXTILE (CHITTAGONG FASHION GROUP)

**PLOT # 26, ROAD # 4, SECTOR # 1, CEPZ,
CHITTAGONG**

June 23, 2014

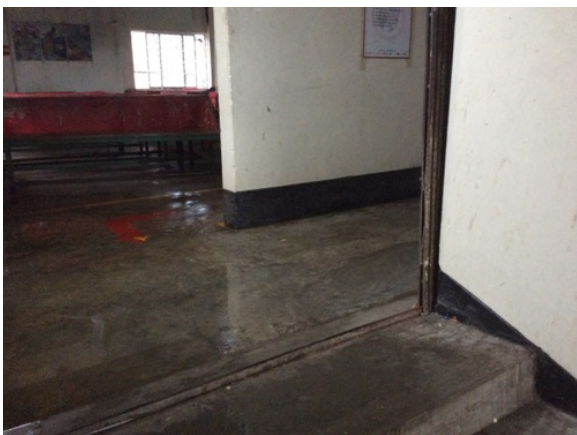
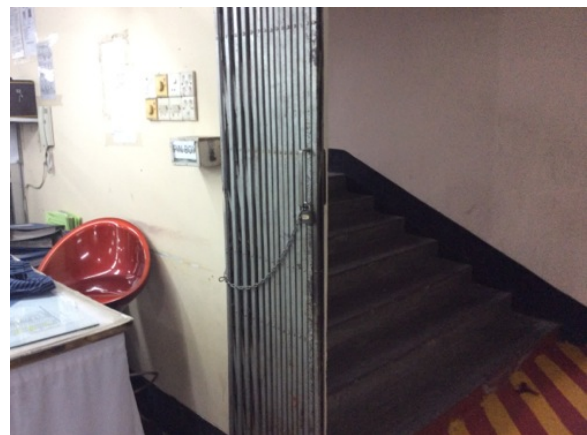
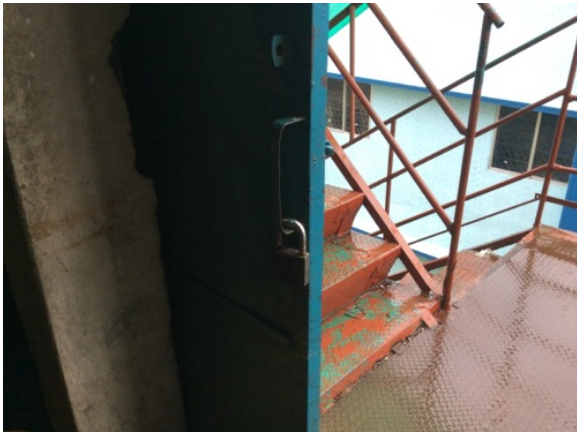
No.	Category	Finding	Recommendation	Remediation Timeframe
F-1	Fire Rated Construction	The exit stairs are not separated from work areas and other spaces on each floor by fire-rated construction.	<p>Provide minimum 1.5-hr fire rated doors and seal all unprotected openings to separate the exit stairs from work areas and other building spaces on all floor levels. Ensure that the fire doors are self-closing and positive latching and that they are provided with fire exit (panic) hardware where serving production floors.</p> <p>If fire doors are required to be held open for functional reasons, provide automatic-closing devices tied to the fire alarm system.</p>	Within 3 months

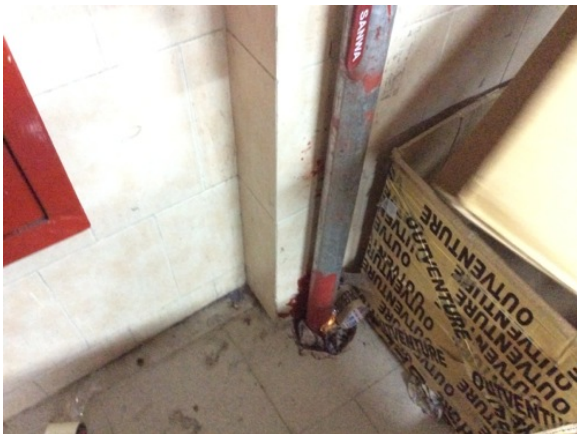
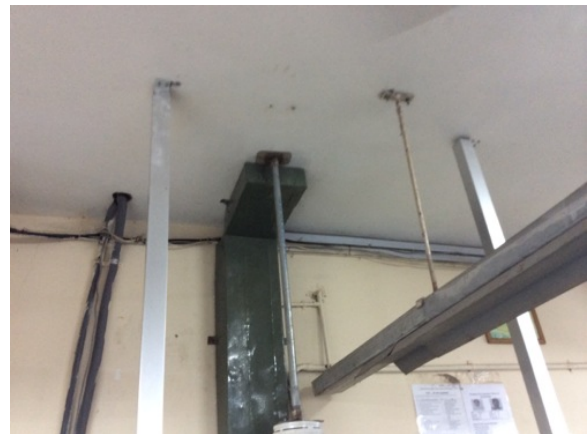
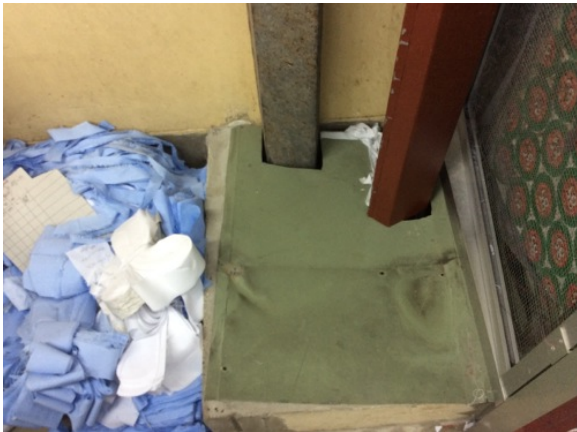
F-2	Fire Rated Construction	Unsealed penetrations and openings are located in the fire-rated floor and ceiling assemblies.	Provide a minimum 2-hr fire-rated shaft to separate the utility risers from each floor level.	Within 3 months
-----	-------------------------	--	---	-----------------

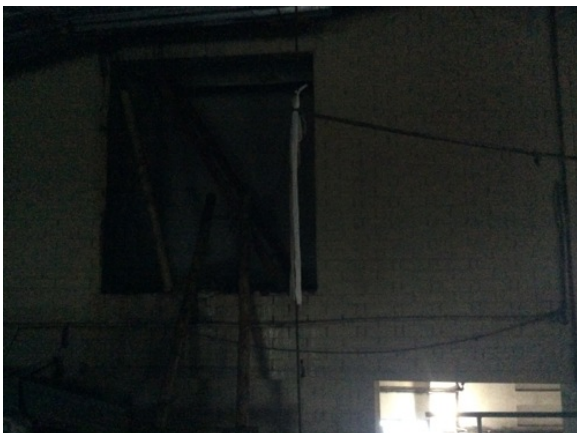
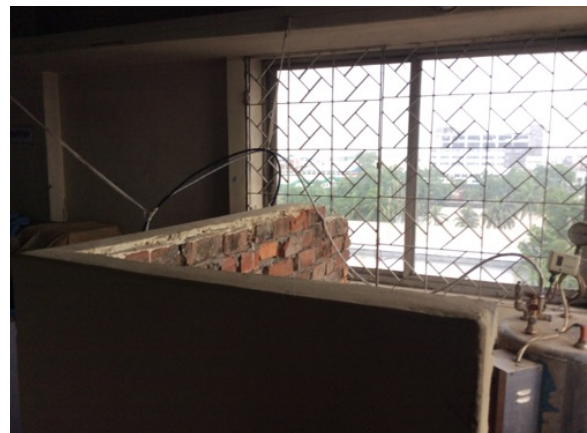
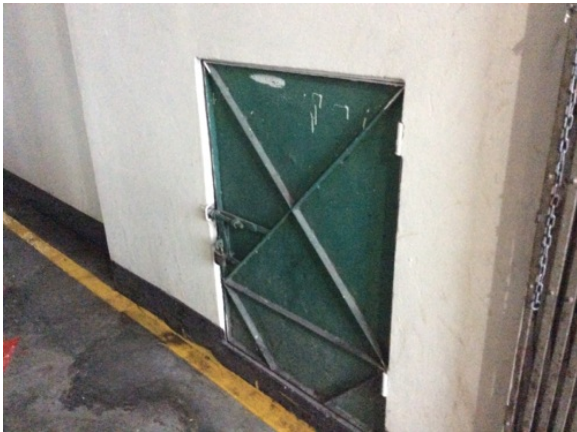
F-3	Fire Rated Construction	The boiler, generator, transformer and EMR room is not separated by fire-rated construction due to openings, non-rated doors and penetrations on the ground, fourth, sixth and seventh floor.	Separate the boiler, generator, transformer and EMR room by a minimum 2-hr fire-rated construction. Seal and protect all openings to maintain the required fire separations.	Within 3 months
-----	-------------------------	---	--	-----------------

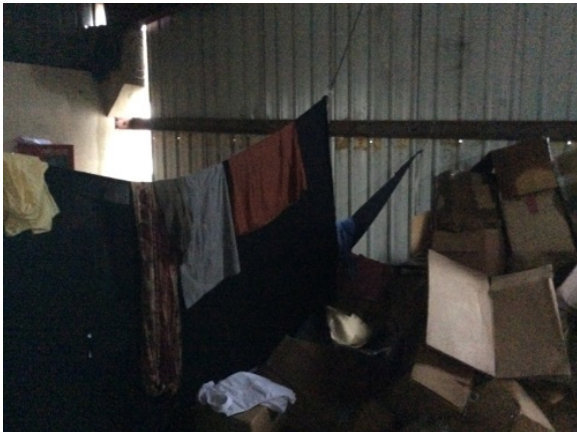
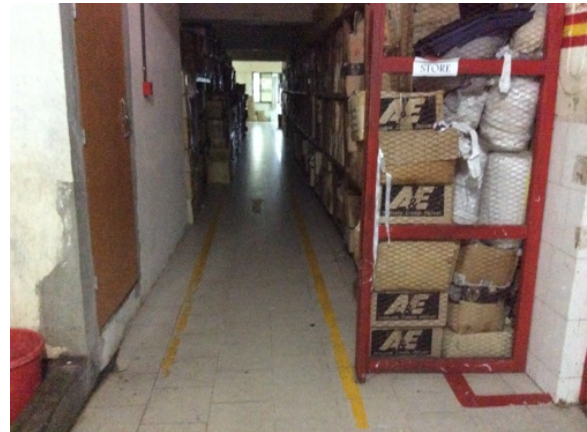
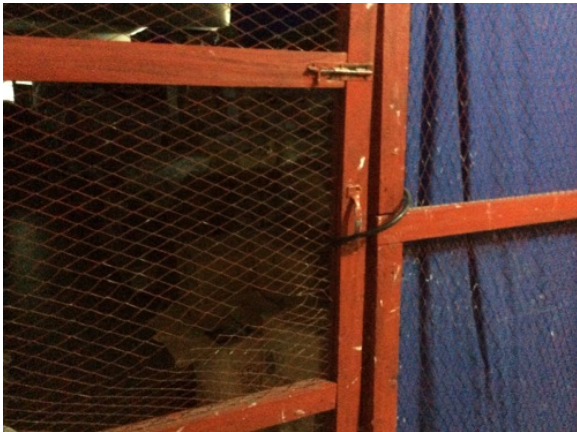
F-4	Fire Rated Construction	Storerooms used for combustible storages are not separated by fire-rated construction on ground, third, fifth and seventh floor.	Provide dedicated storage rooms separated by minimum 1-hr fire-rated construction.	Within 3 months
-----	-------------------------	--	--	-----------------

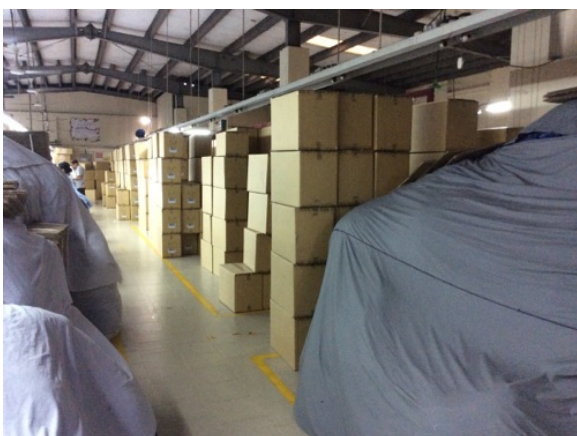
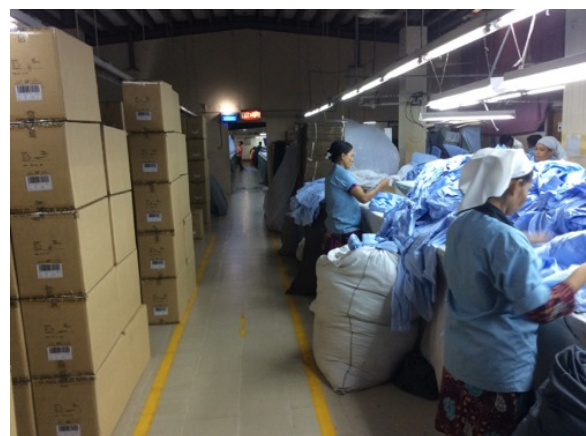
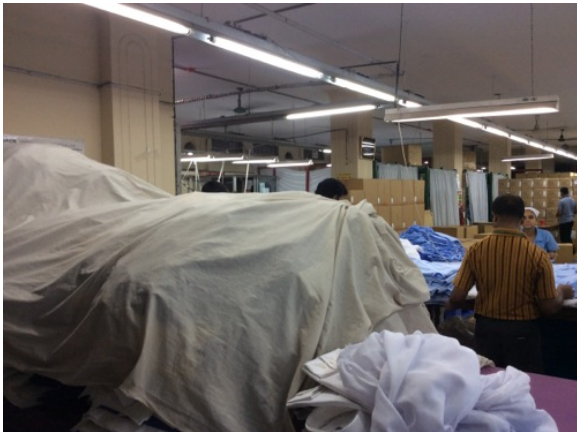
F-5	Fire Rated Construction	Areas used for combustible storages are open to factory floors on ground and fourth floor.	Provide defined storage areas and limit the storage arrangement as follows: <ul style="list-style-type: none">- Maximum height of 2.4m and maximum area of 23 m2.- Separate areas of unenclosed combustible storage by a minimum clear distance of 3 m.	Within 3 months
-----	-------------------------	--	--	-----------------

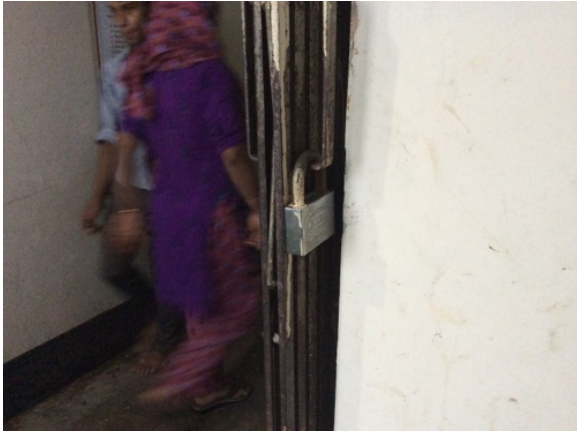
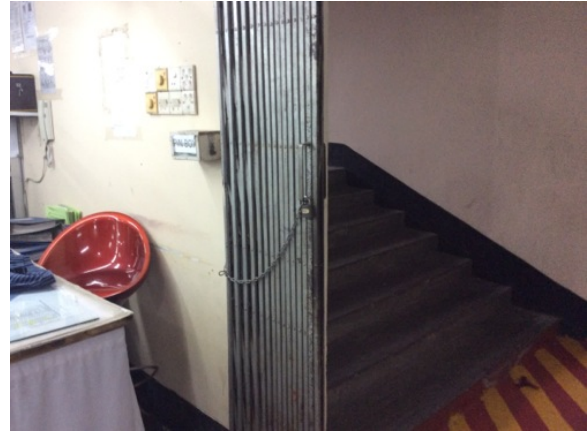
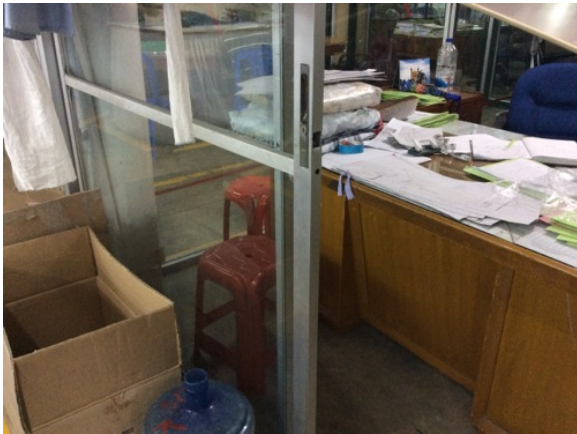
F-6	Egress	Exit capacity (359) is not adequate for the occupant load (370) on the sixth floor.	Reduce occupant load to not more than available exit capacity (359). Provide additional exits in the future to increase occupant load.	Immediate
F-7	Egress	Egress doors and gates with locking features (padlocks) are provided at building exits, exit stairs and along egress routes. All gates and doors were not open and unlocked during the inspection.	<p>Remove locking features from all egress doors and gates.</p> <p>If locks are required for security reasons, utilize special door locking features complying with NFPA 101.</p>	Immediate

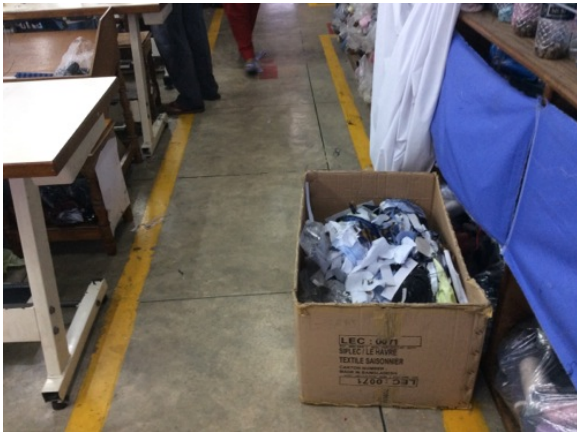
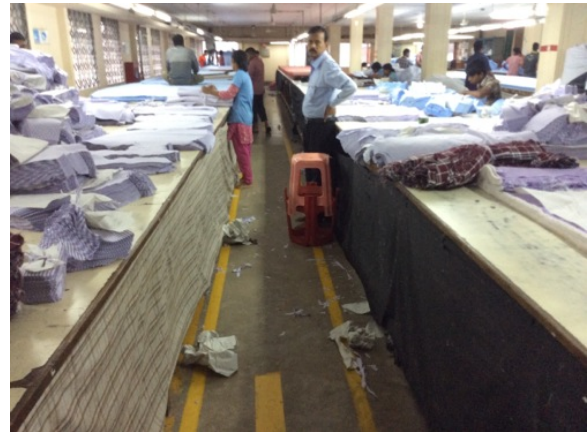
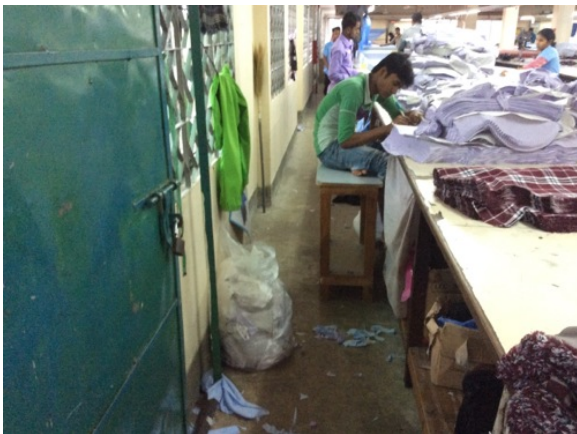
F-8	Egress	Storage is located in the egress path on all the floors except sixth and seventh floors.	Keep egress paths and stairs clear of storage.	Immediate
-----	--------	--	--	-----------

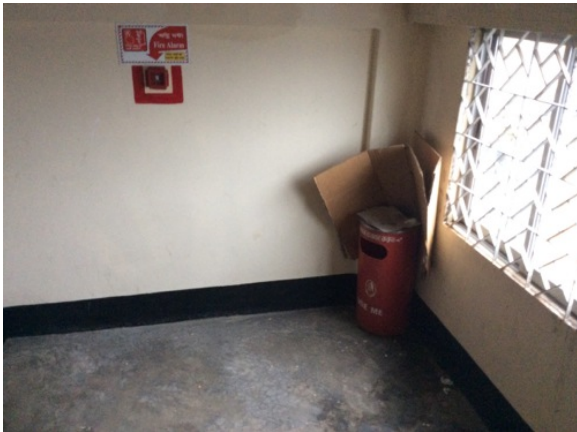
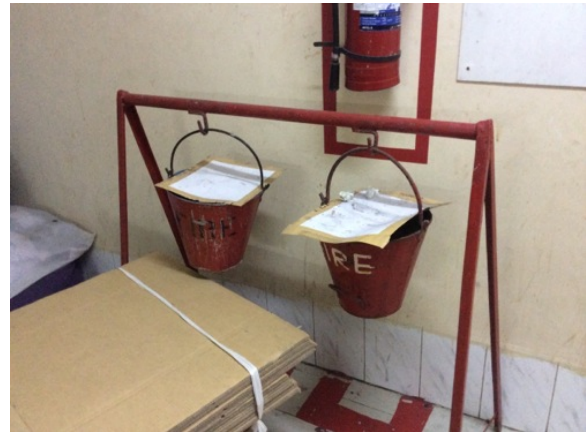
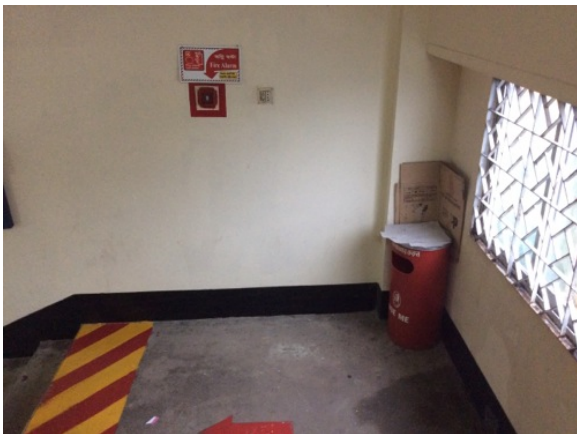
F-9	Egress	Storage is located in all the exit stairs on all the floors.	Remove all storage from exit stairs and egress paths.	Immediate
-----	--------	--	---	-----------

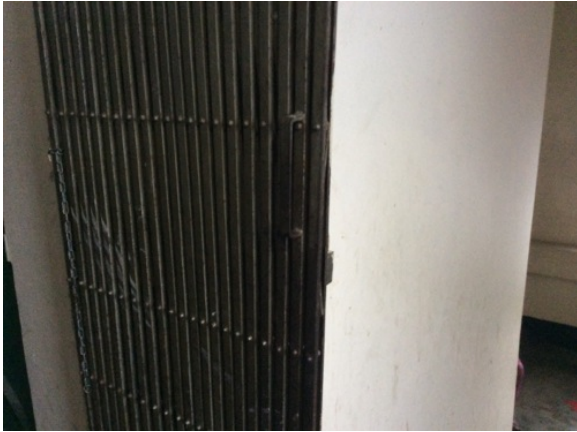
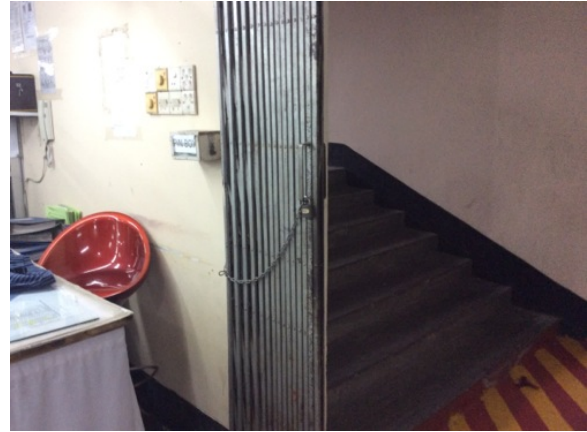
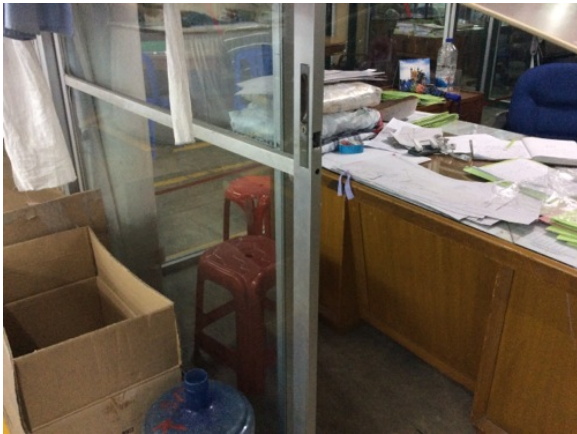
F-10	Egress	Collapsible gates and sliding doors are provided at building exits, exit stairs, along egress routes and exit discharge.	Replace all gates and sliding doors along the means of egress with side-hinged, swinging egress doors. If locks are required for security reasons, utilize special door locking features complying with NFPA 101.	Within 1 month
------	--------	--	--	----------------

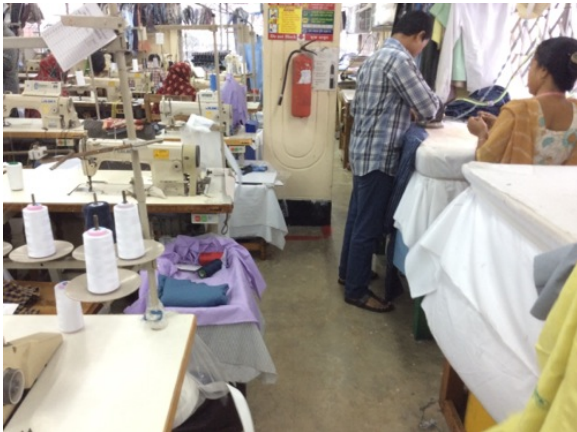
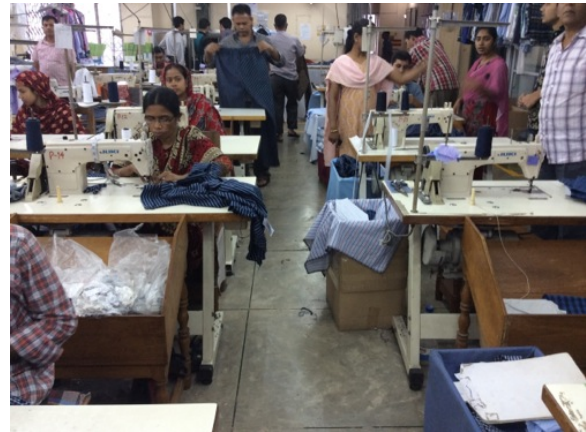
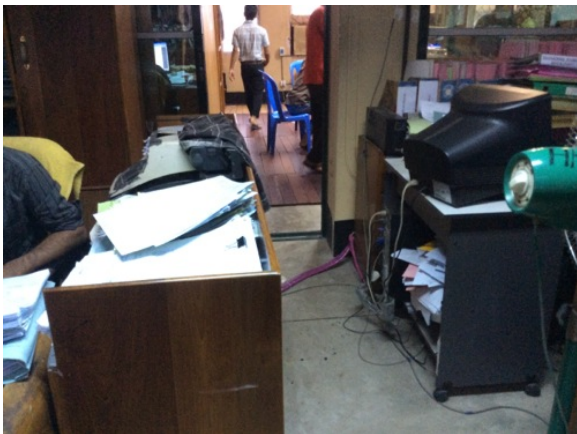
F-11	Egress	The width of egress aisles is less than 36-in. on all the floors except sixth and seventh floors.	Provide minimum aisle widths of 36-in.	Within 3 months
------	--------	---	--	-----------------

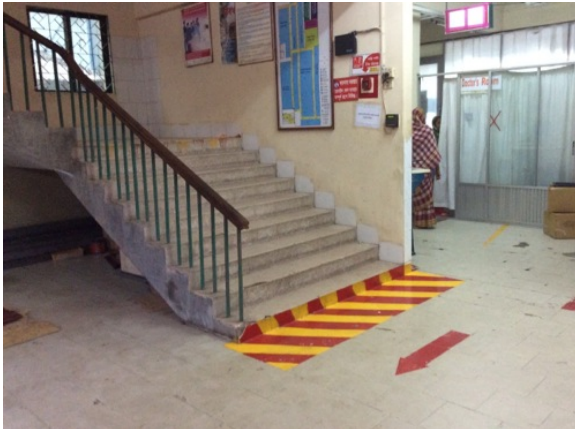
F-14	Egress	West exit stairs discharge inside the building on the ground and fourth floors and discharge through Production and Storage areas.	Provide 2-hr fire-rated exit passageway leading directly outside (vestibules to separate any storage areas).	Within 6 months
------	--------	--	--	-----------------

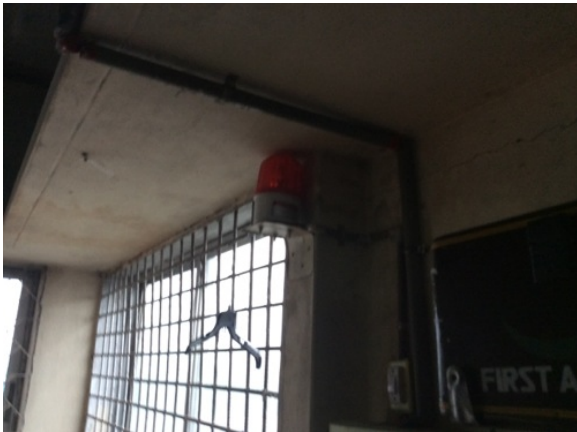
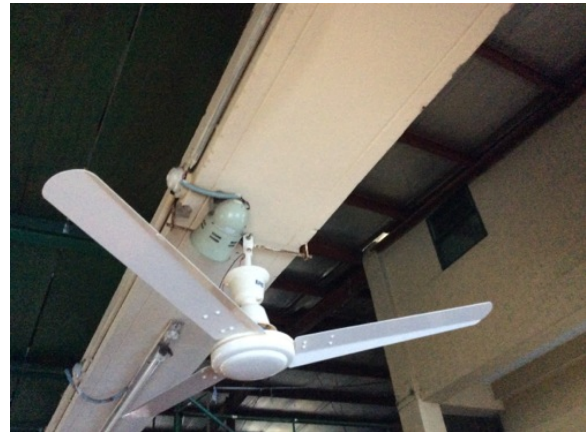
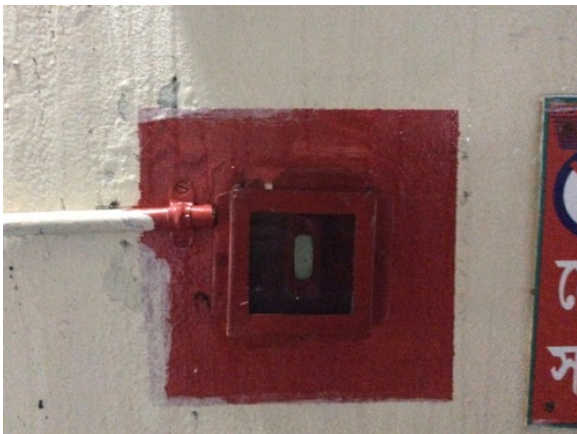
F-15	Fire Protection	The fire alarm system is antiquated, not a listed system, and does not provide alarm and notification features consistent with acceptable standards.	Replace the fire alarm system with a new, listed addressable fire alarm system in accordance with NFPA 72.	Design within 4 months, install within 9 months
------	-----------------	--	--	---

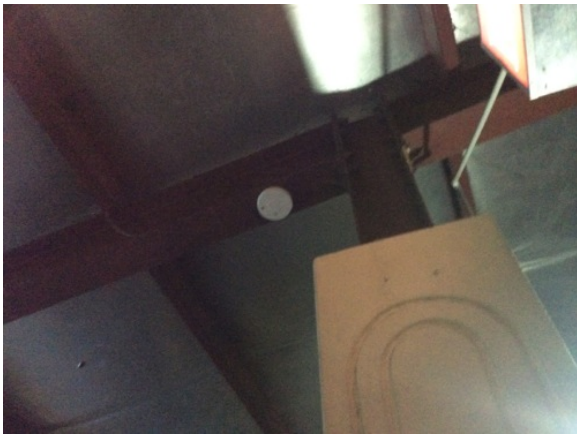
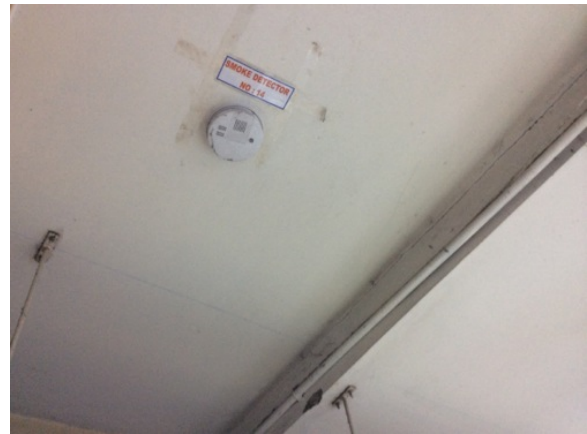
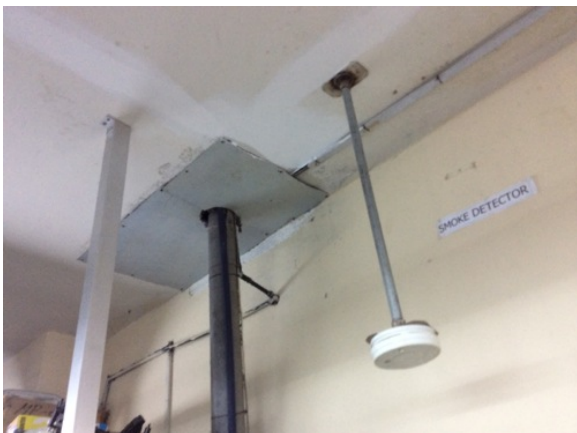
F-17	Fire Protection	The building is equipped with single-station smoke alarms. Smoke alarm activation sounds only a local alarm and does not provide automatic fire alarm notification of occupants.	Remove single station smoke alarms. Provide automatic smoke detection throughout the building in accordance with NFPA 72.	Within 6 months
------	-----------------	--	---	-----------------

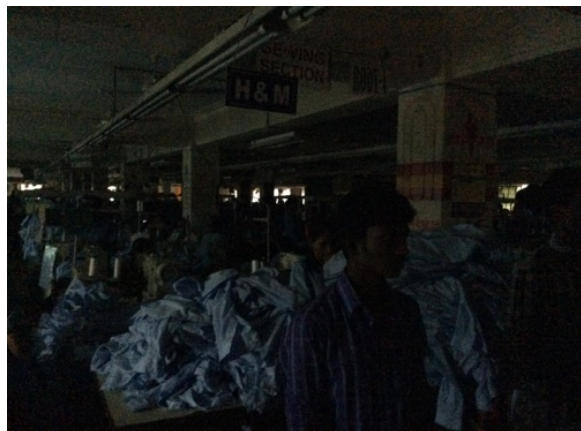
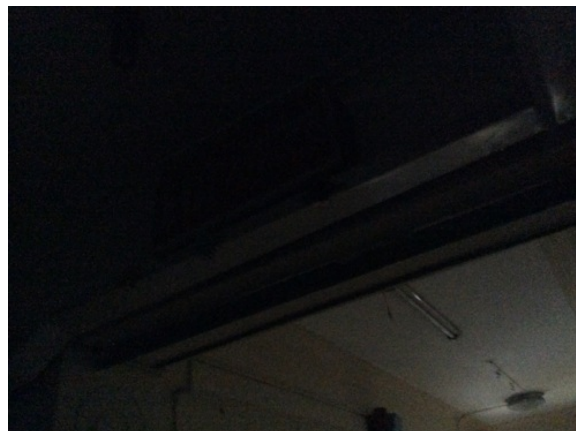
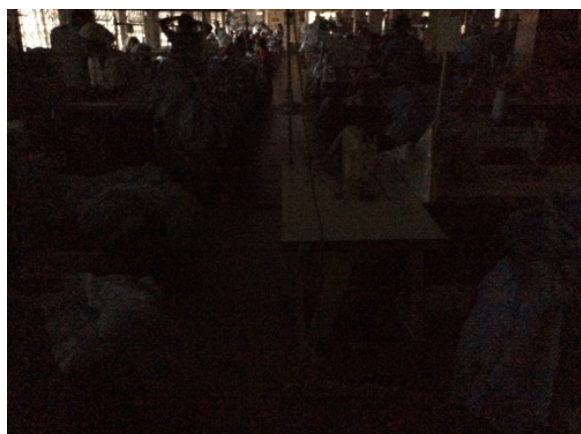
F-18	Egress Lighting	Emergency lighting did not function in test mode on the second floor.	Regularly test the emergency lighting system on each floor and replace and repair emergency lighting system including the alternative Instant Power Supply as needed.	Within 1 month
------	-----------------	---	---	----------------

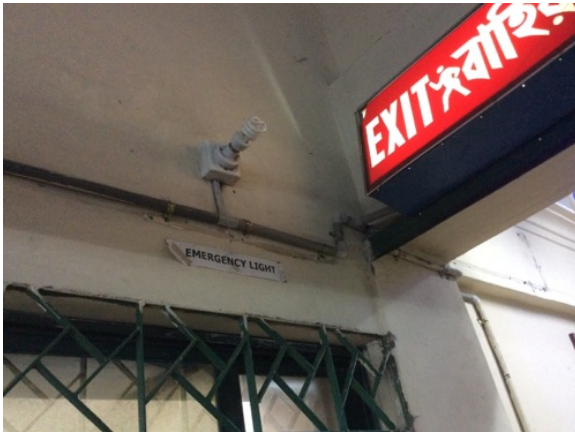
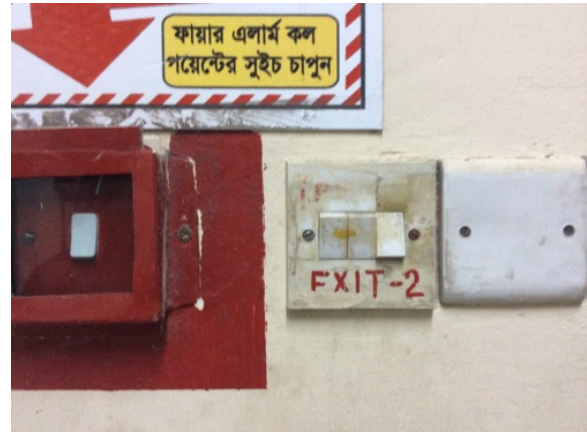
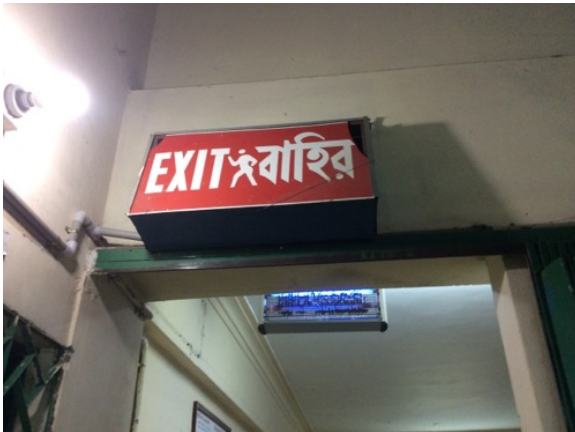
F-19	Egress Lighting	Manual on-off switch is provided for emergency lighting and exit signage units in the West exit stair.	Remove manual on/off switches from emergency lighting and exit signage units to prevent them from being switched off.	Within 1 month
------	-----------------	--	---	----------------

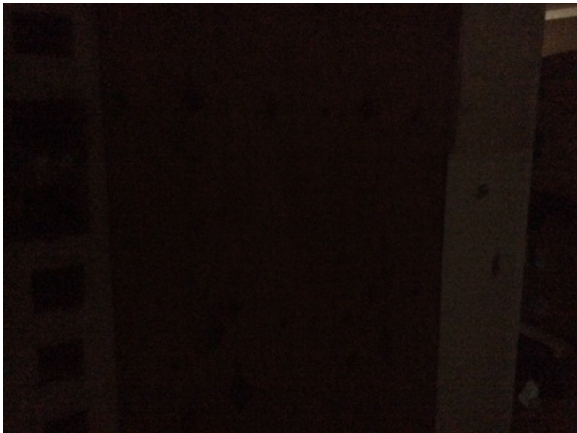
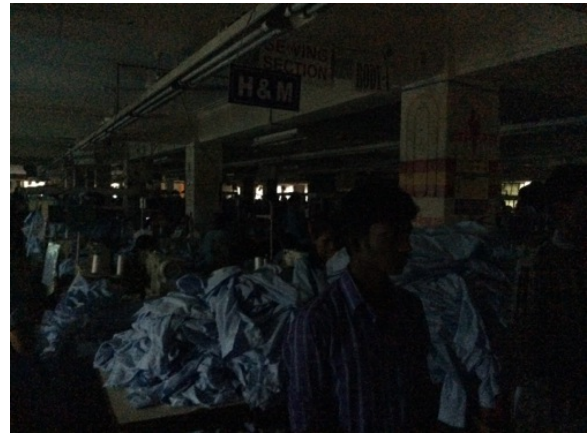
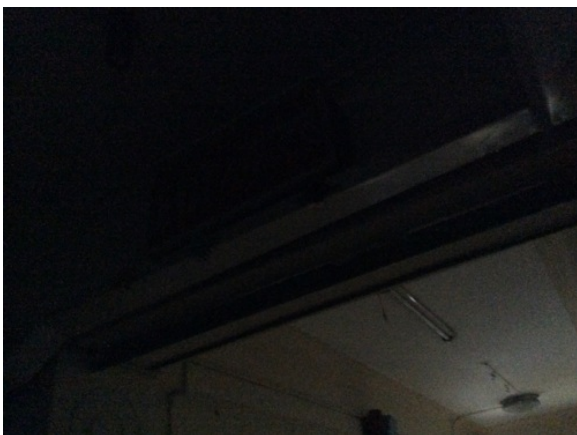
F-21	Egress Lighting	Based on the number and location of emergency lights observed, adequate illumination levels are not anticipated along egress routes on the factory floors and exit stairs.	Test the emergency lighting system on each floor and provide additional emergency fixtures to provide adequate illumination along the means of egress. Provide a minimum illumination of 10 lux at the floor level within exit stairs and exit discharge paths and minimum 2.5 lux along exit access aisles.	Within 3 months
------	-----------------	--	--	-----------------
