Chittagong Fashion Specialized Textiles Ltd

Plot No 26, Sector 1, Road 4, CEPZ, Chittagong
(+22.29119N, 91.77497E)

11 February 2014

Building Observations

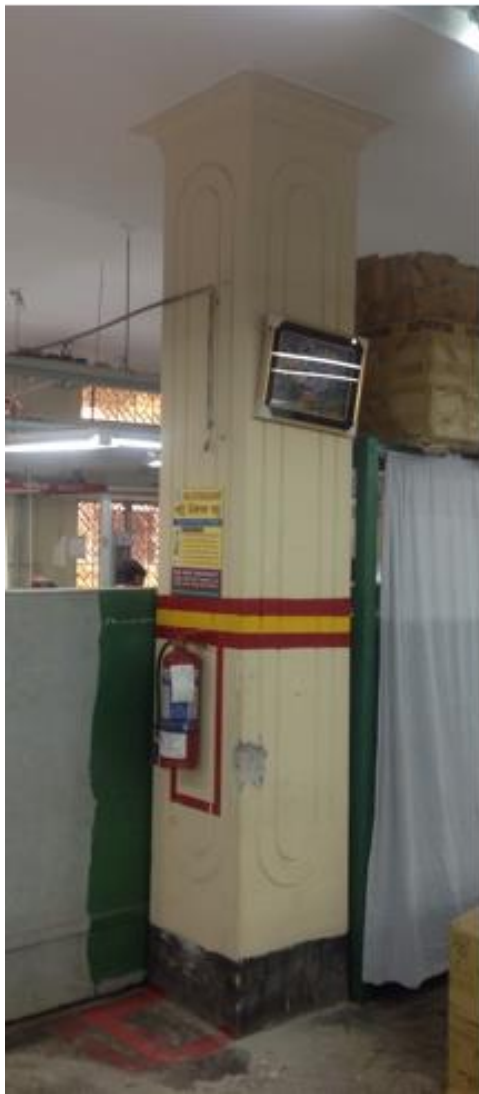
East Block

**Columns appear to be stressed in excess of
normal design limits**

Cursory calculations indicate that column size appears to be smaller than required by code for the applied dead and live load, assuming typical concrete strength

Building Engineer to perform detailed calculations and concrete tests to prove column size and (if required) :

- Reduce loads by preparation of allowable floor loading plans
- Carry out strengthening works

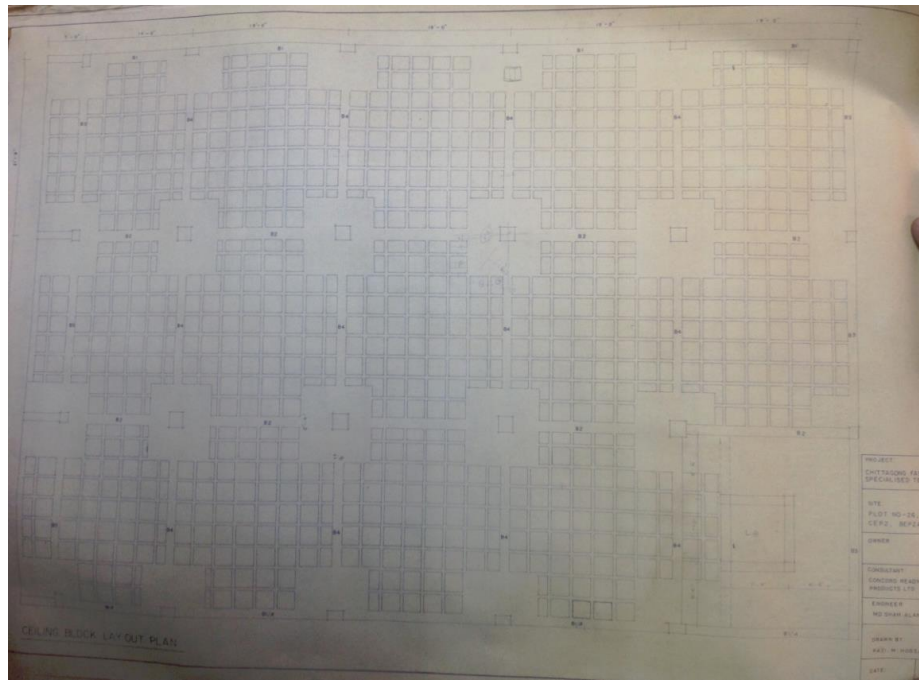
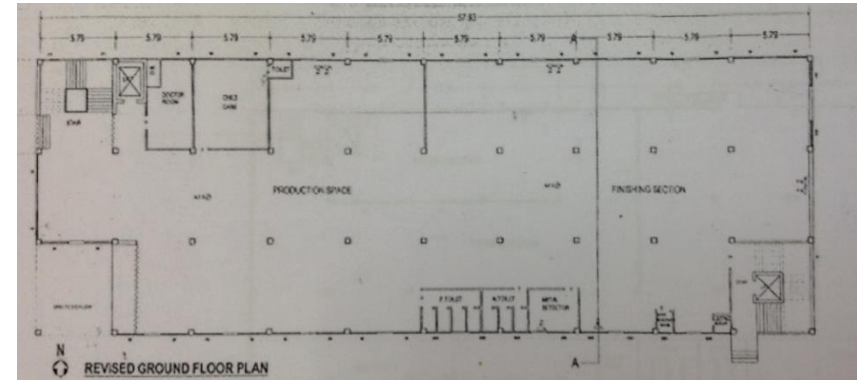
Incomplete & Out of Date Drawings

Structural drawings provided were incomplete and do not fully represent the as-constructed building structure

Structural drawings show a single structural system rather than the as- built structure which is effectively two separate but interconnected buildings with different structural systems.

Column grid dimensions in the East – West direction do not correspond between the permit drawings and the as- built structure.

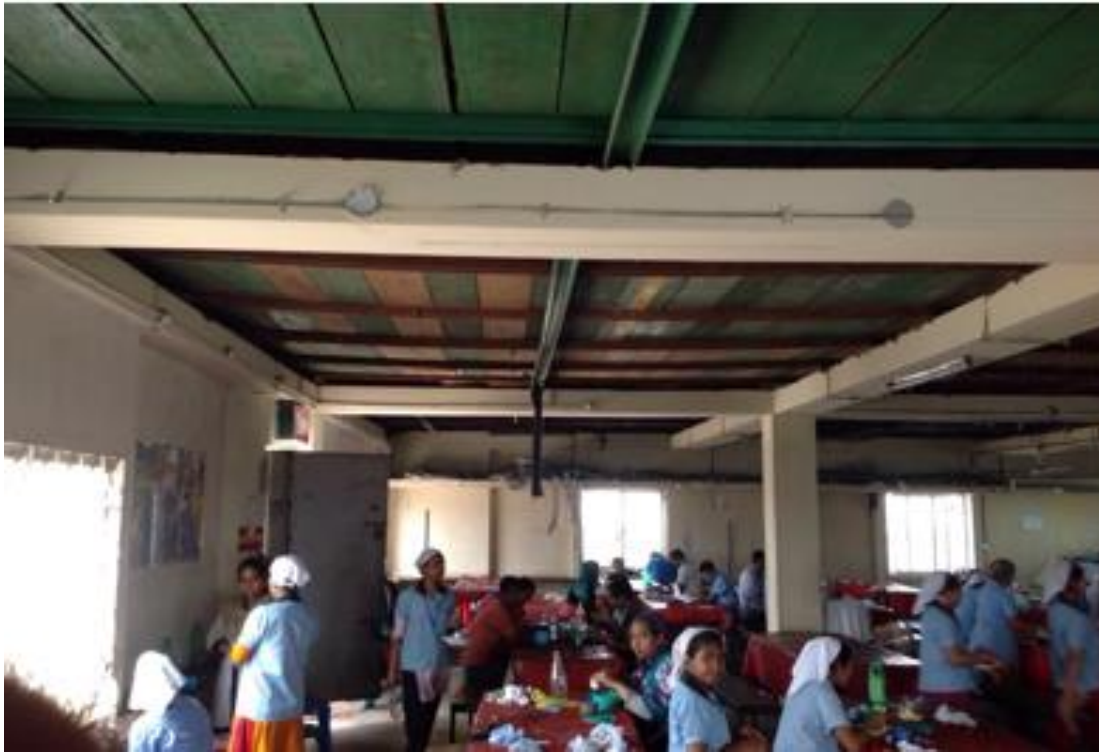
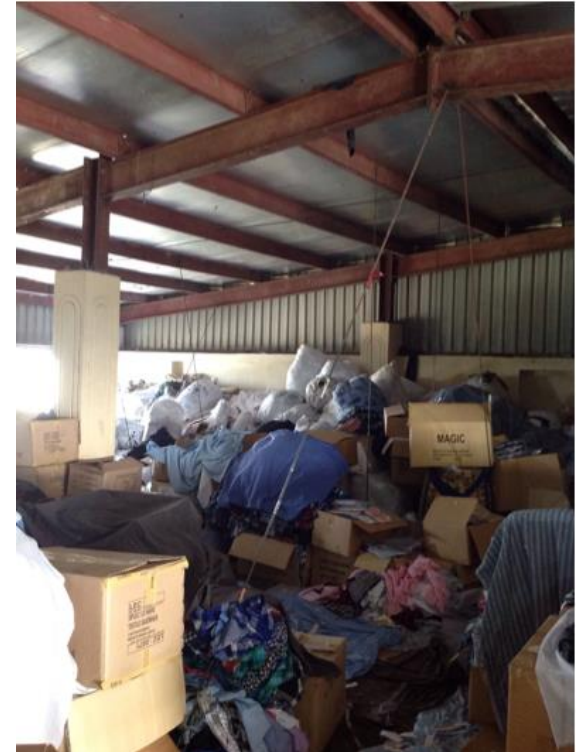
Mezzanine Storage Floor.

Visible sagging in mezzanine floor beams above Dining Area– East Block

Visible sagging in support beams for mezzanine above the Dining Area. This mezzanine floor is used as a storage zone.

Building Engineer to review and prepare calculations to verify the structural adequacy of the mezzanine floor and supports.

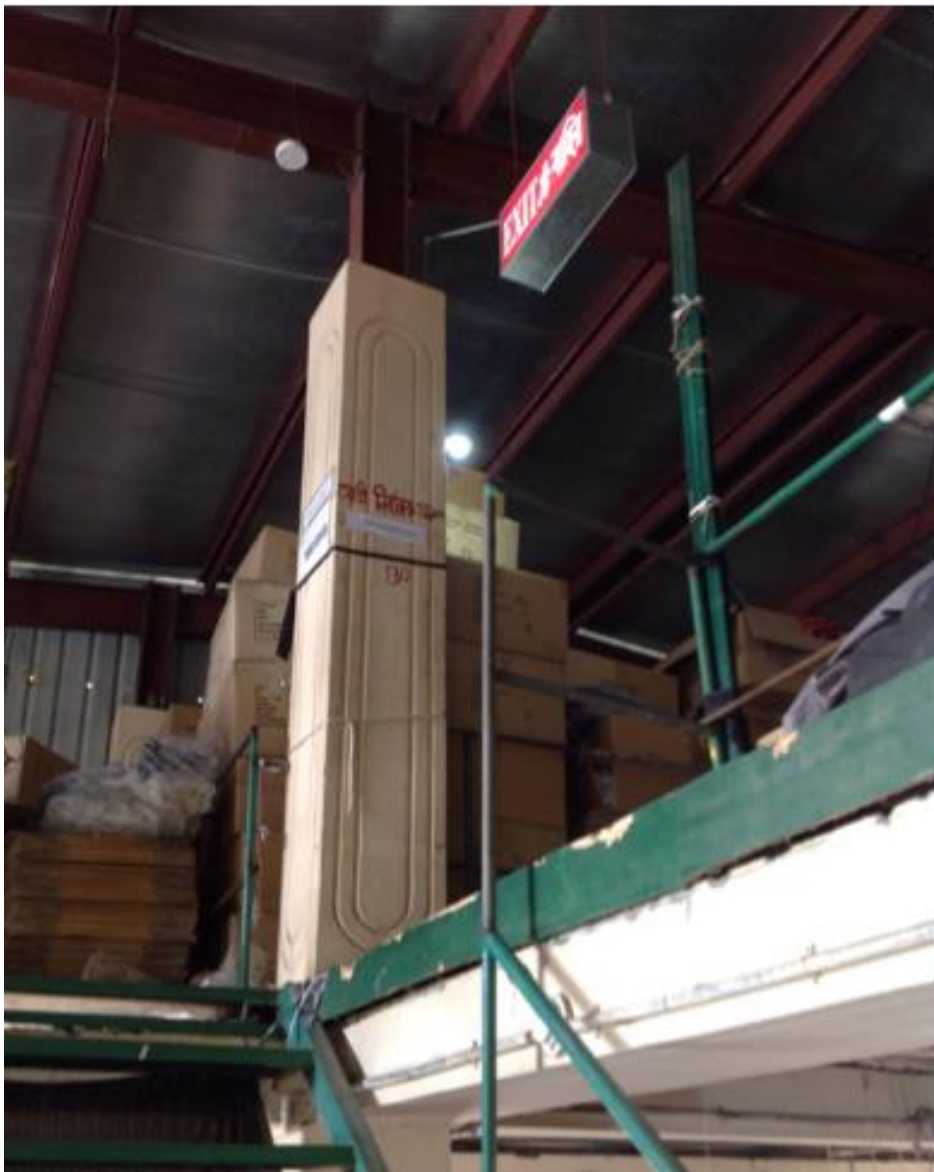
Lateral stability of Roof above Dining Area Mezzanine.

Lightweight steel roof to the East Block does not appear to be adequately braced to resist high wind loading

Roof stability appears reliant on stiffness of supporting columns, purlins and light deck roof – Building Engineer to review.

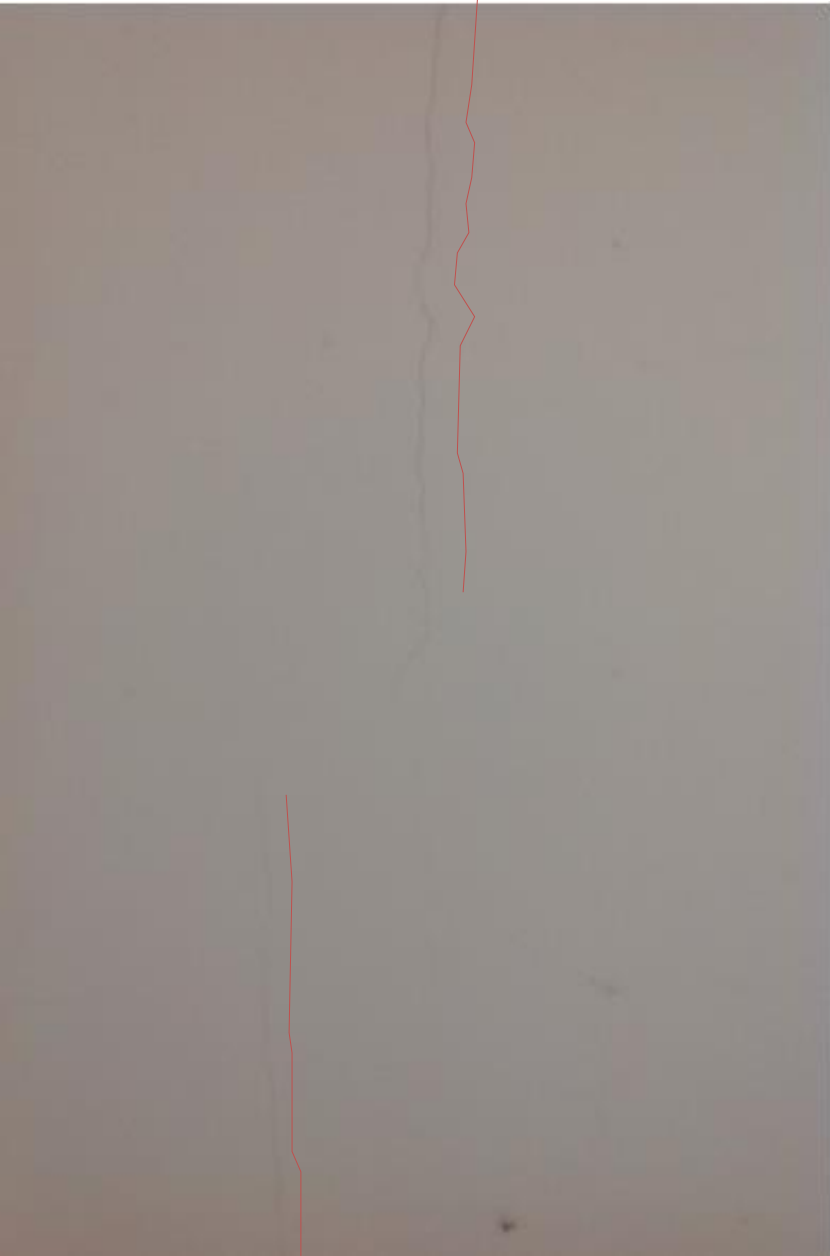
Cracking on underside of East Block floor slab

Cracking to underside of floor slab throughout East Block

East Block floors appeared initially to be of flat slab construction. Long, relatively straight cracks could be seen on the slab soffits throughout the building – primarily running east-west but with some running north-south. There were often two or more cracks running parallel to each other.

Drawings indicate that a waffle slab has been constructed. The Factory engineer advised that waffles had been in-filled by permanent brickwork. This may be reflective of the crack lines. We are unclear how the brickwork is retained in position on the slab soffit.

Building Engineer to review and confirm that the above is correct and advise how brick formwork is retained in position to ensure that the slab soffit cracking does not develop further.

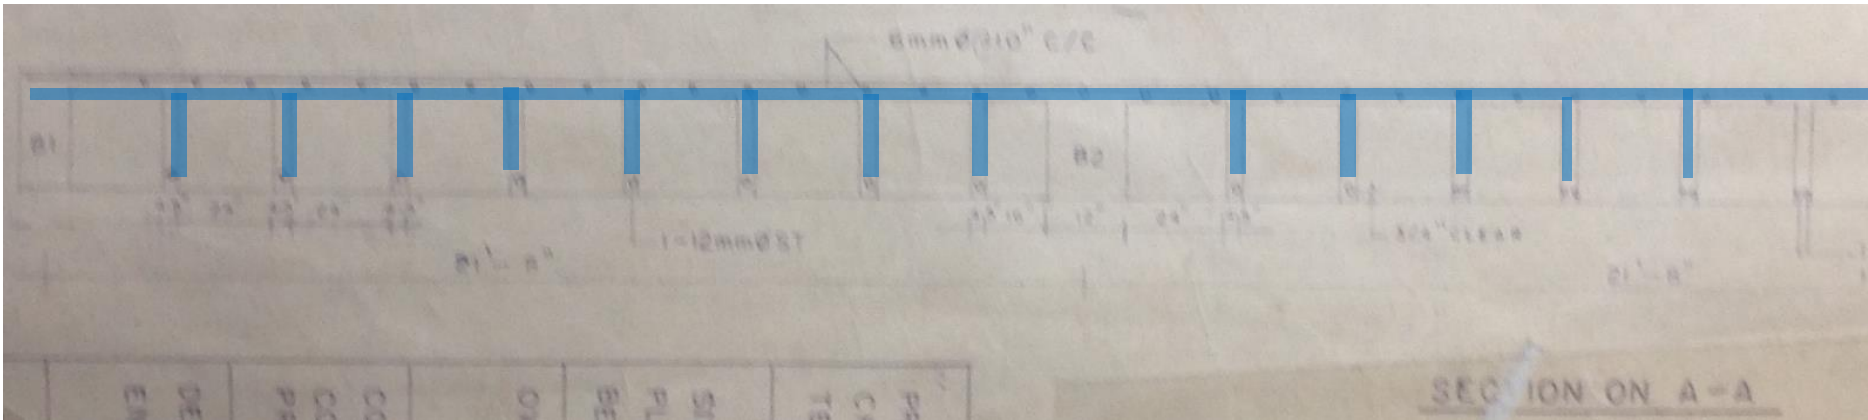
Section of waffle slab shown on structural drawing.

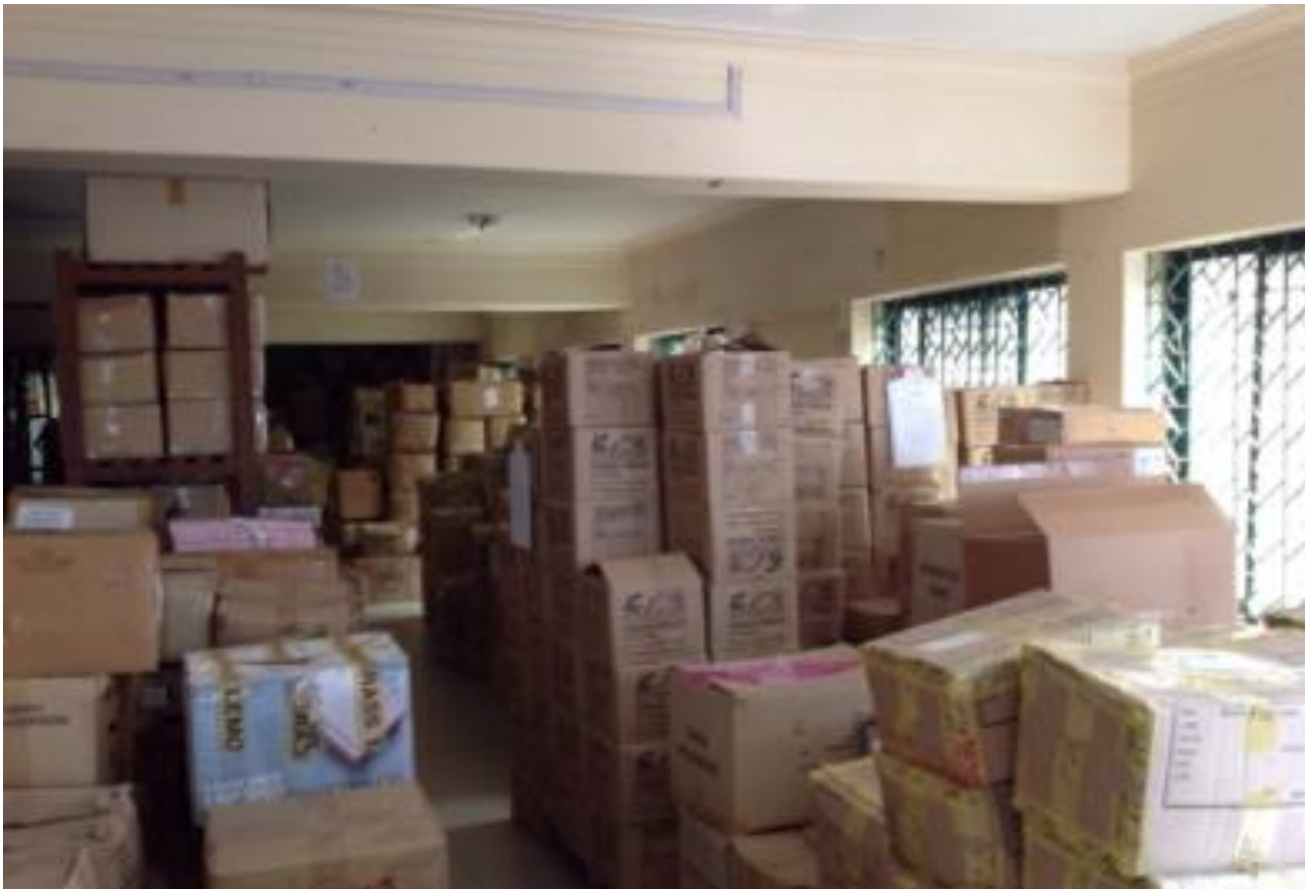
Second Floor

Management of storage loads - East & West Blocks

**Some level of Storage loads were observed on all floors.
Plan and height restrictions to be introduced to prevent future overloading.**

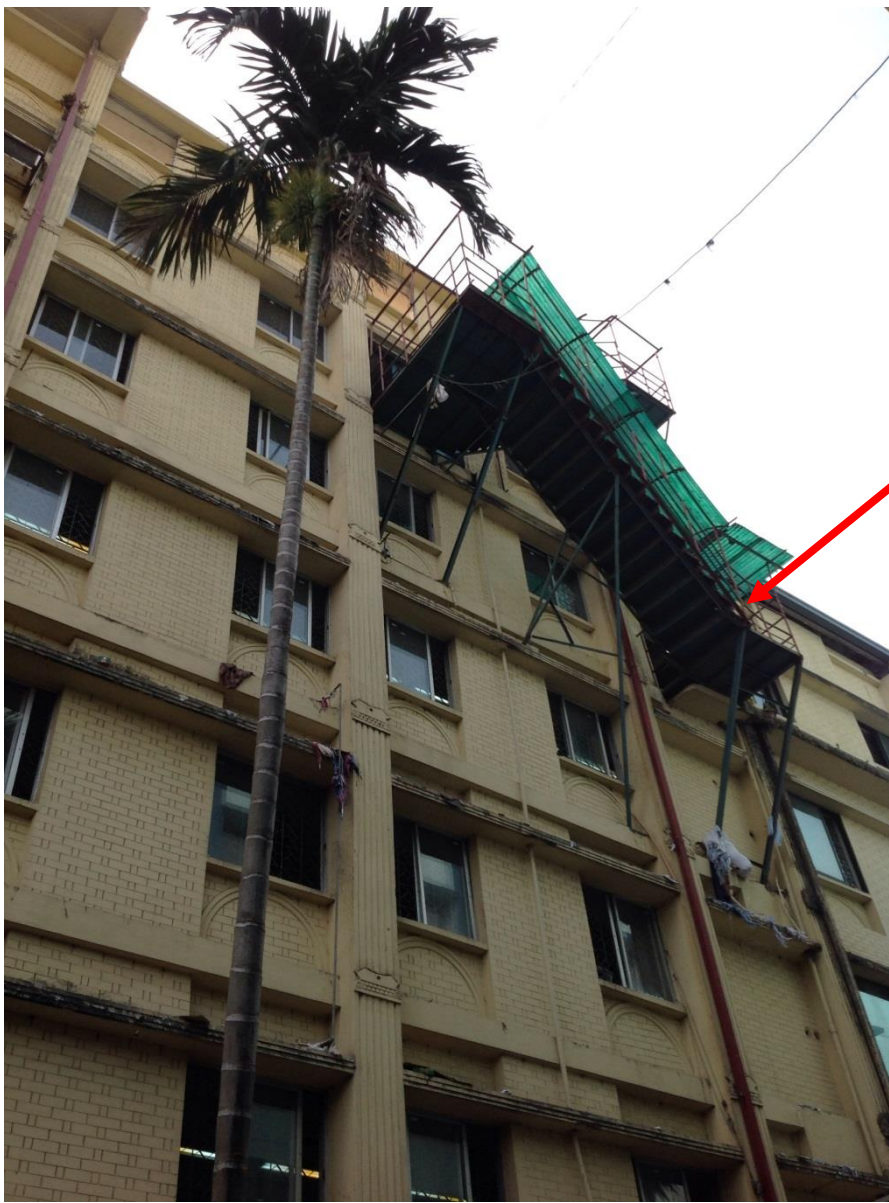
External Fire Escape Stairs

Load capacity of external fire escape stairs

External fire escape stairs. Building Engineer to verify that the structural load capacity of stairs and supports back to building structure are adequate for crowd loading.

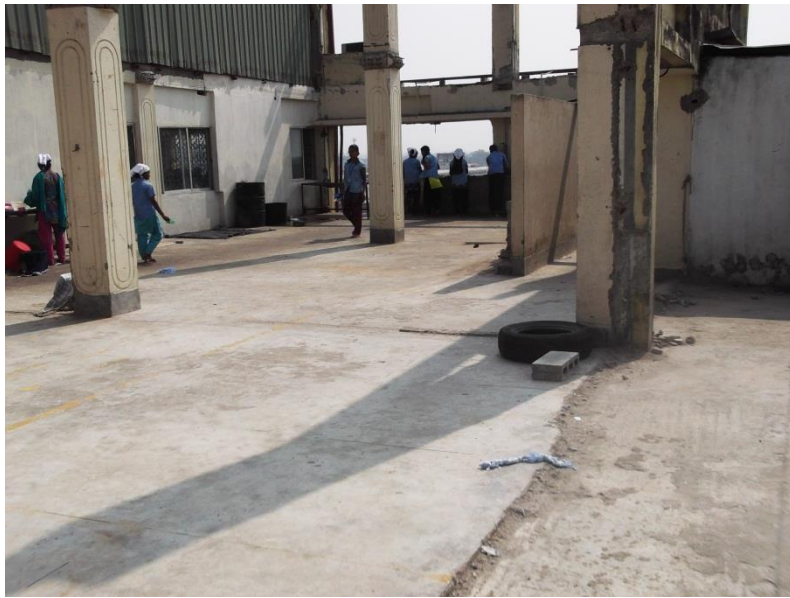
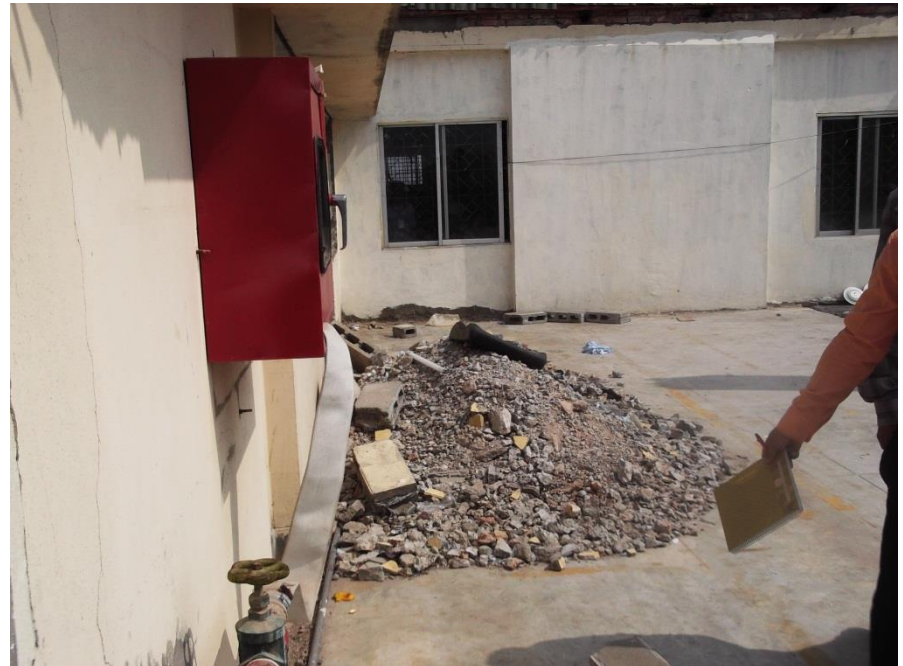
Works at Roof Level

Condition of roof slab following demolition works – tidy-up, waterproofing and drainage to be provided

- Remove construction material
- Provide waterproofing to damaged areas
- Provide a roof drainage system
